WSTF-IR-1129-001-08
December 10, 2008

Investigation, Analysis, and Testing of Self-contained Oxygen Generators

**Lyndon B. Johnson Space Center
White Sands Test Facility
PO Box 20
Las Cruces, NM 88004
(575) 524-5011**

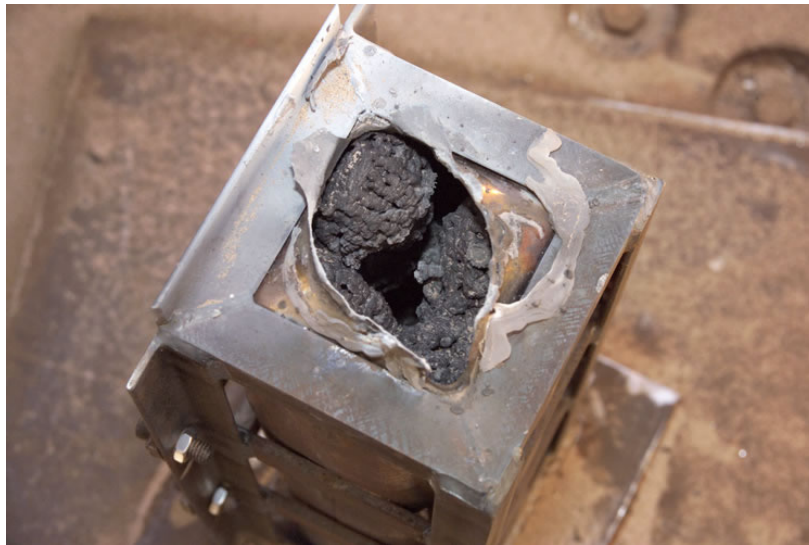
Figure 40
Top of SCOG26 (Test 8)

- Posttest examination revealed only the top section of the canister had burned through, and the ductile deformed filter plate was ejected from the hole created (Figure 41).

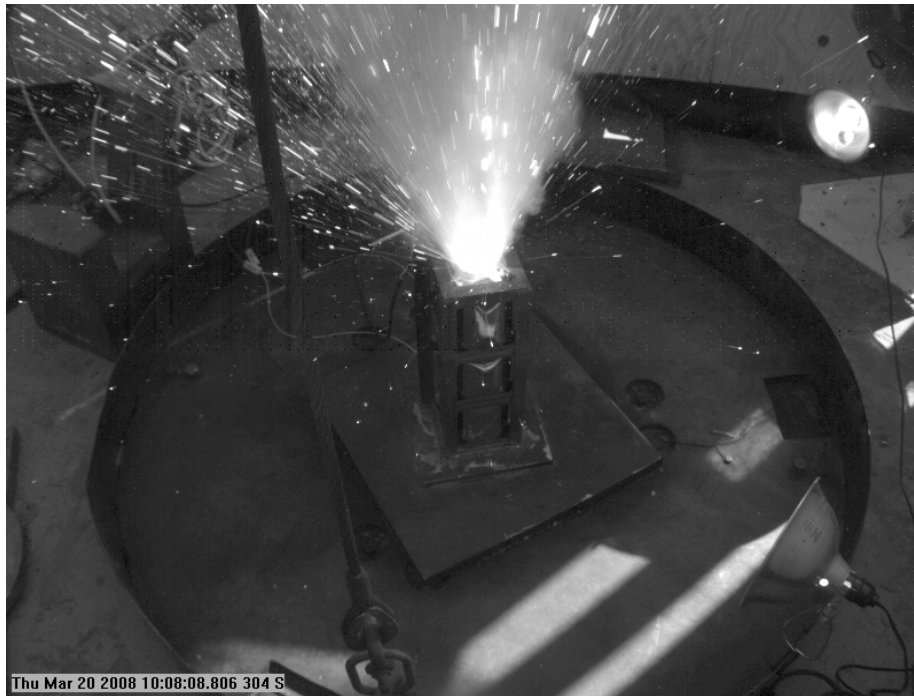
Figure 43
Pyrotechnic Behavior, Test 9 ($t = 1.000$ s)

- The .410 cartridge was initiated (remotely).
- Hissing sound occurred.
- Canister bulged.
- Pressure relief devices opened at $t = 0.558$ s.
- Ejection of vapor and particulate from vent ports began ($t = 0.750$ s).
- Flames and pyrotechnic-like behavior ($t = 0.750$ to 1.066 s) (Figure 43).
- Top of canister breached and ejection of material and vapor increased ($t = 1.068$ s) along with a fireball several feet in diameter (Figure 44).
- The camera enclosures were shaken by a moderate pressure pulse accompanying the breach and first fireball event.
- Several smaller fireball events occurred in escaping cloud, and vapor thickened in enclosure ($t = 1.069 - 1.340$ s), along with continued pyrotechnic-like behavior.
- Flames died down and candle burned for remainder of test ($t = 1.34+$ s).

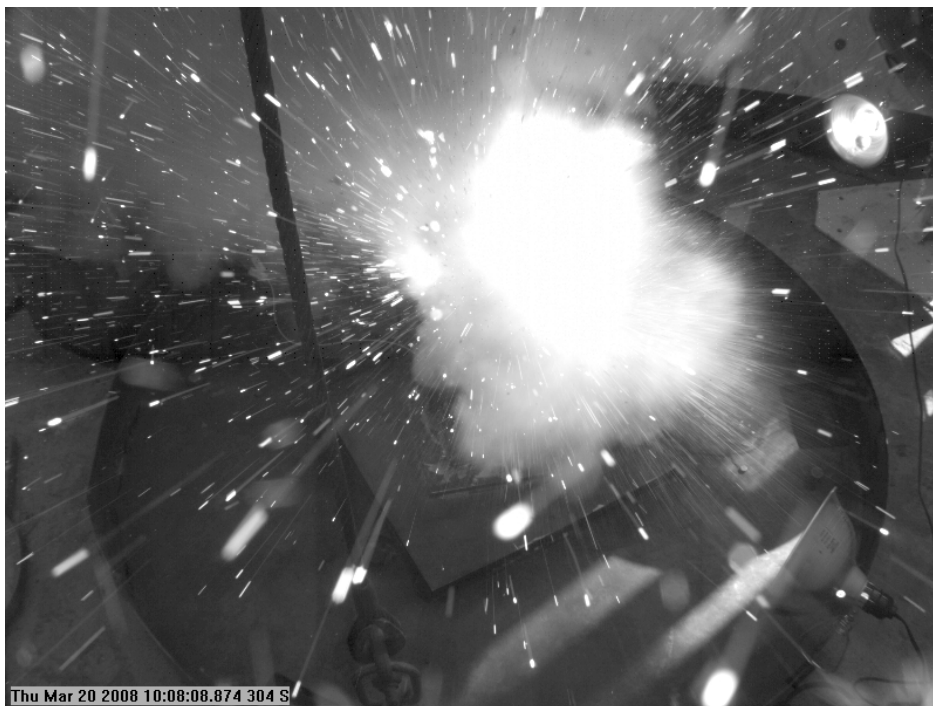
Figure 44
Primary Ejection Event, Test 9 ($t = 1.068$ s)

- The SCOG26 exhibited violent pyrotechnic-like behavior.
- Gas production increased beyond nominal operation, and some bulging of the canister was evident prior to pressure relief valve activation.
- The event was similar to Test 8, with pyrotechnic behavior and ejection of material.
- The inner filter plate was found to be severely deformed and was ejected violently from the SCOG26 with some candle material.
- There was evidence of a secondary pressure wave behavior during the ejection event.
- Several fireball events, several feet in diameter, occurred in the escaping vapor and particulate cloud.
- The sidewalls and bottom of the canister remained intact.
- The solenoid striker remained attached to the peeled-back lid portion (Figure 45).
- Posttest examination revealed only the top section of the canister had burned through and the filter plate was ejected from the hole created.

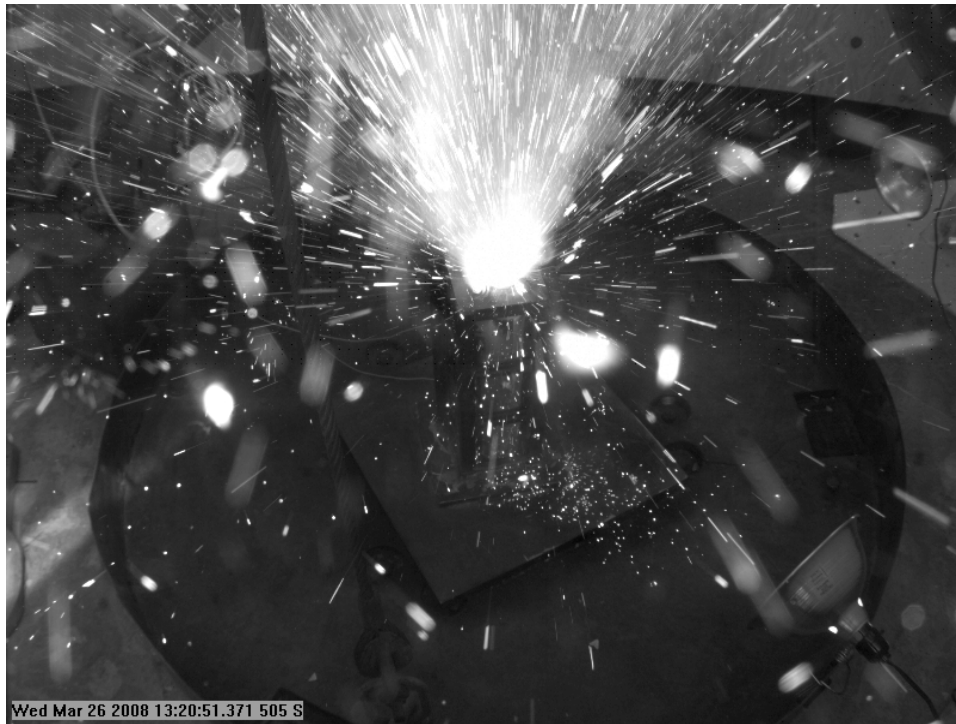
Figure 47
Pyrotechnic Behavior Test 10 ($t = 0.957$ s)

- The .410 cartridge was initiated (remotely).
- Hissing sound occurred.
- Canister bulged.
- The pressure relieve devices activated at $t = 0.645$ s after initiation.
- Small flames and particulate continued to eject from pressure relief ports from $t = 0.645$ to 0.855 s.
- Vapors and particulate began to eject through the primary vent paths at $t = 0.855$ s.
- Pyrotechnic behavior increased and remained until $t = 1.250$ s before flames nearly disappear (Figure 47).
- Material was ejected in a burst of vapor and particulates at $t = 1.263$ s, accompanied by a pressure wave that shook the camera enclosures (Figure 48).
- Vapor density in enclosure increased.
- Flames died down at $t = 1.590$ s, and material continued to burn inside the canister to test completion.

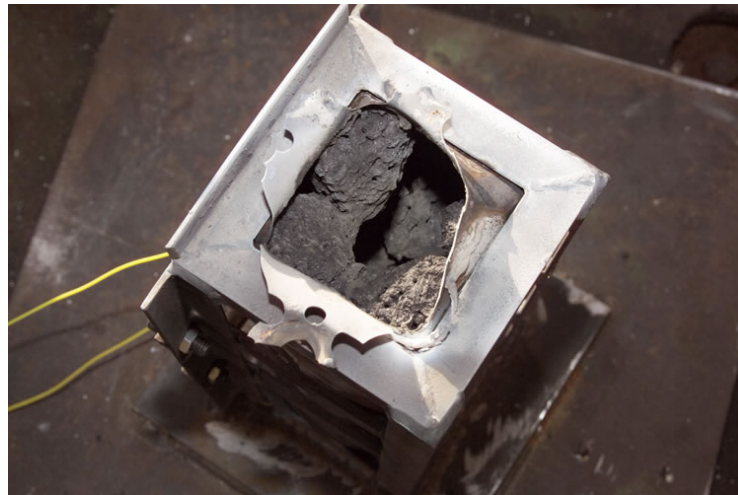
Figure 49
Top View of SCOG26 (Test 10)

- The SCOG26 exhibited violent pyrotechnic-like behavior.
- Gas production increased beyond nominal operation, and some bulging of the canister was evident prior to pressure relief valve activation.
- The event was similar to Test 8 and Test 9, with pyrotechnic behavior and ejection of material.
- The inner filter plate was found to be severely deformed and was ejected violently from the SCOG26 with some candle material.
- There is evidence of a secondary pressure wave behavior during the ejection event.
- Some minor fireball events were seen after the primary ejection event.
- The sidewalls and bottom of canister remained intact.
- The solenoid striker was ejected vertically.
- Posttest examination revealed only the top section of the canister had burned through (Figure 49), and the filter plate was ejected from the hole created (Figure 50).

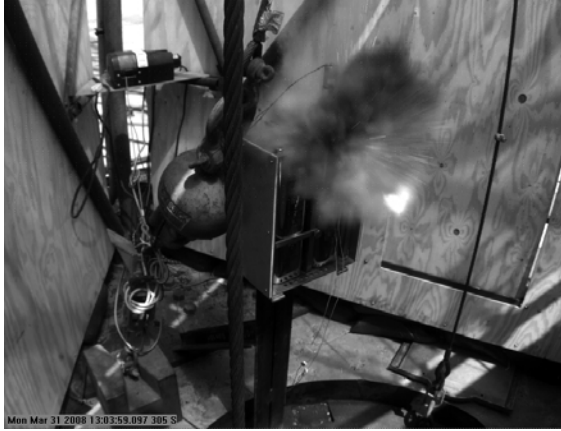
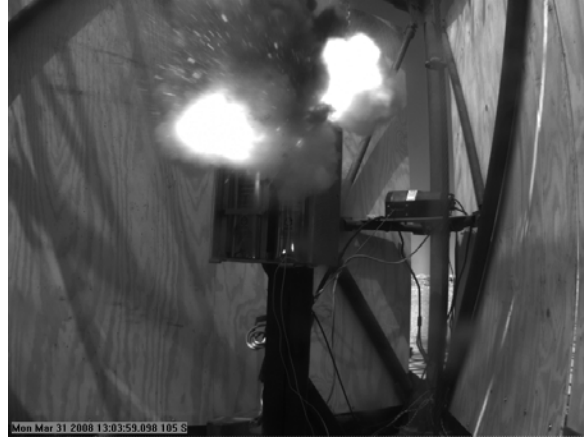
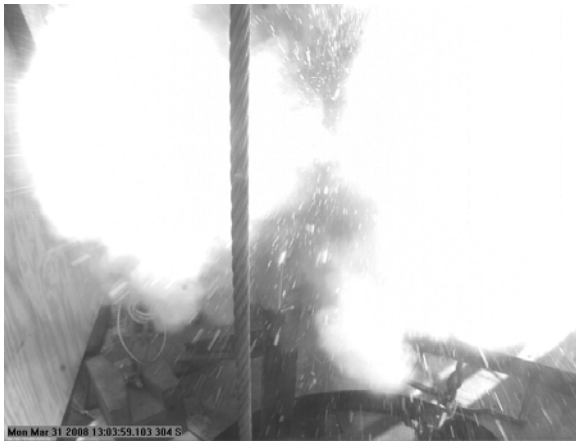
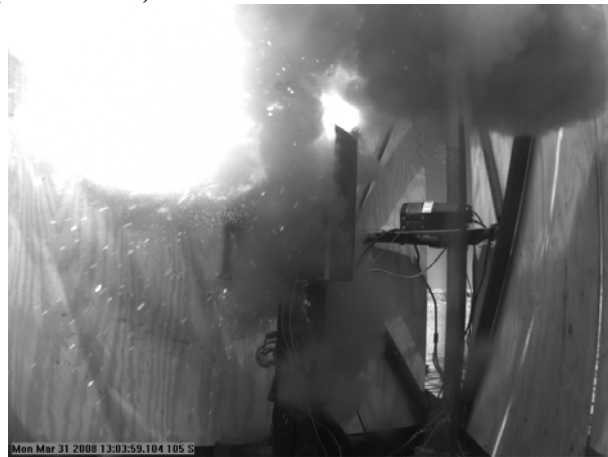
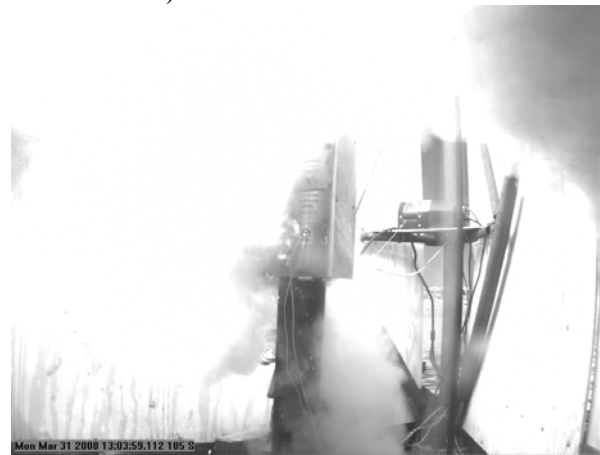
Figure 54
Primary Burst and VCE Formation

$t = 1.198 \text{ s}$ (Initial Burst)

$t = 1.204 \text{ s}$ (VCE Formation)

$t = 1.212 \text{ s}$ (VCE Fills View)

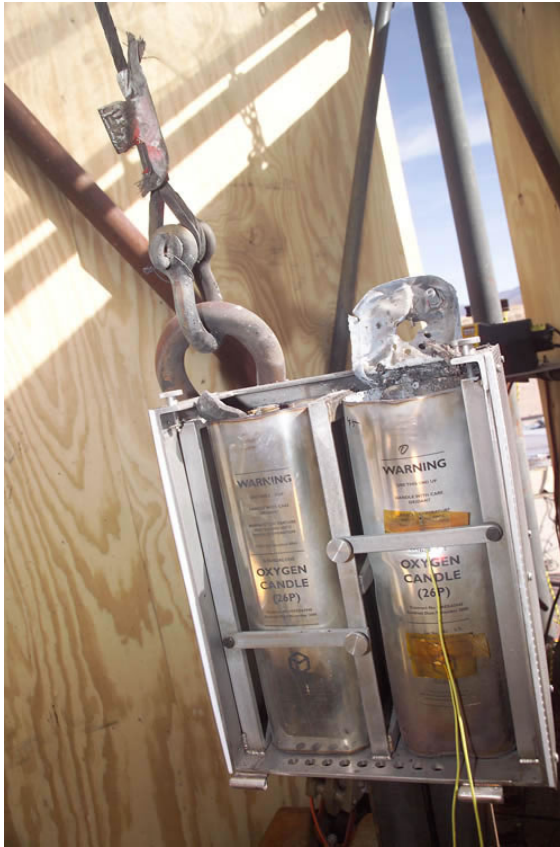
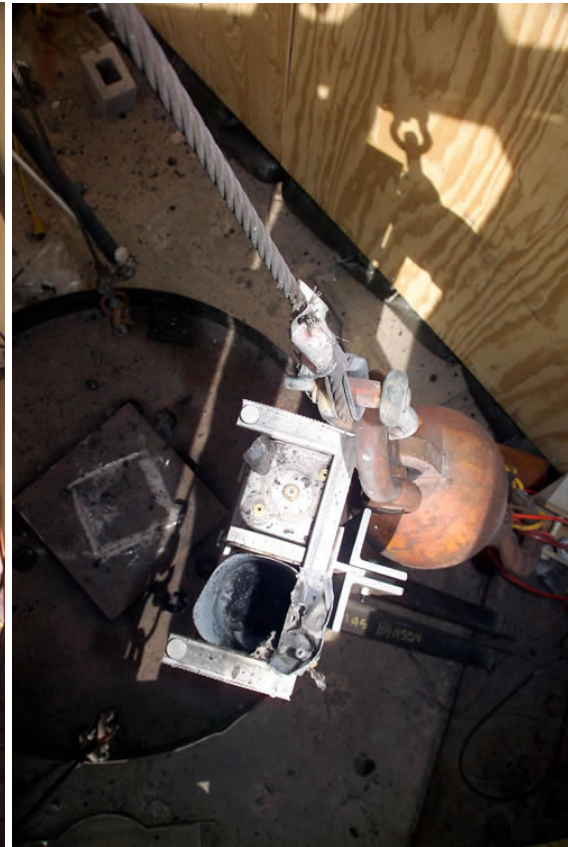
Figure 56
Posttest 11 (2 views)

- Gas production increased beyond nominal operation, and some bulging of the canister was evident prior to pressure relief valve activation.
- This first test using the standard SCOG26 holder showed most of the same general behavior as previous tests; however, the failure point was different and formed at the top front seam of the lid, allowing the top of the canister to peel back and remain attached to the canister (Figure 56).

- The majority of the candle brick was forced to eject from the canister, indicating a pressure buildup near the bottom of the canister.
- The pressure buildup is attributed to a BLEVE-like reaction near the bottom of the canister to drive the brick material out of the vertically standing SCOG26.

- The crack pattern in the COGA11 test article did have a path for fuel to flow towards the bottom of the canister, which is considered the likely reason for a reaction near the bottom of the canister.

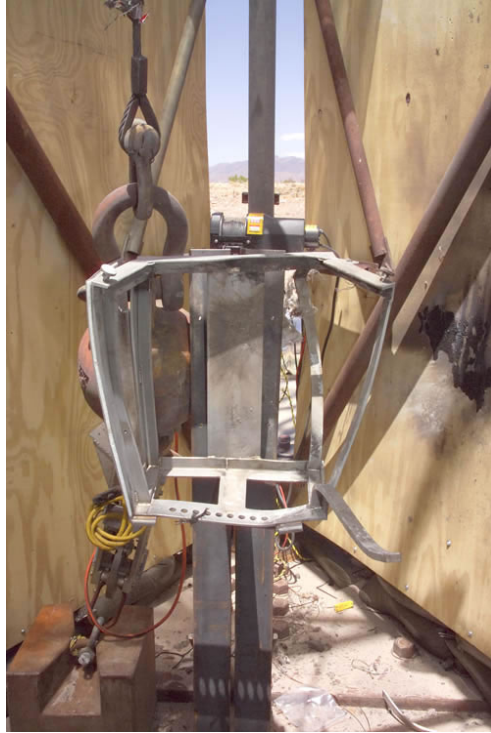
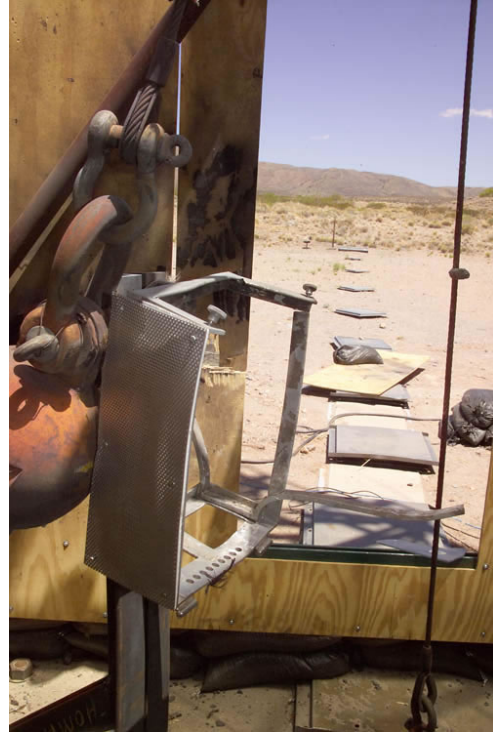
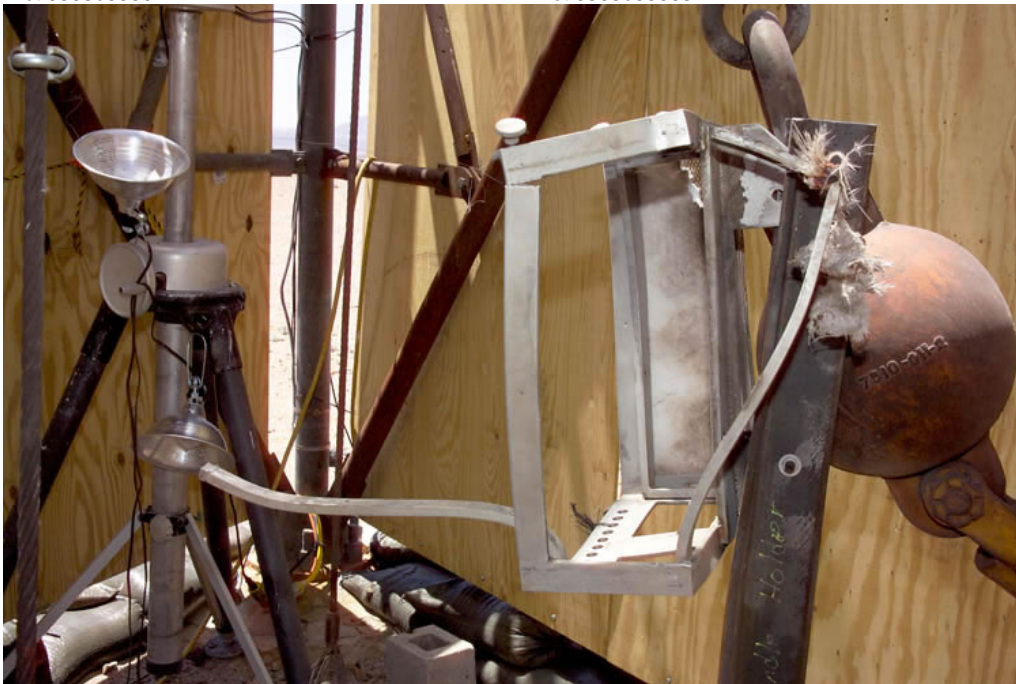
Figure 61
Test 12 Deformation of SCOG26 Holder and Plywood Scorch Marks

- Numerous fragments were driven through or imbedded in the plywood walls in a manner similar to photographic evidence of the accident.
- The “dummy” SCOG26 showed evidence of significant near field pressure damage from the test article generated pressure waves (Figure 62).

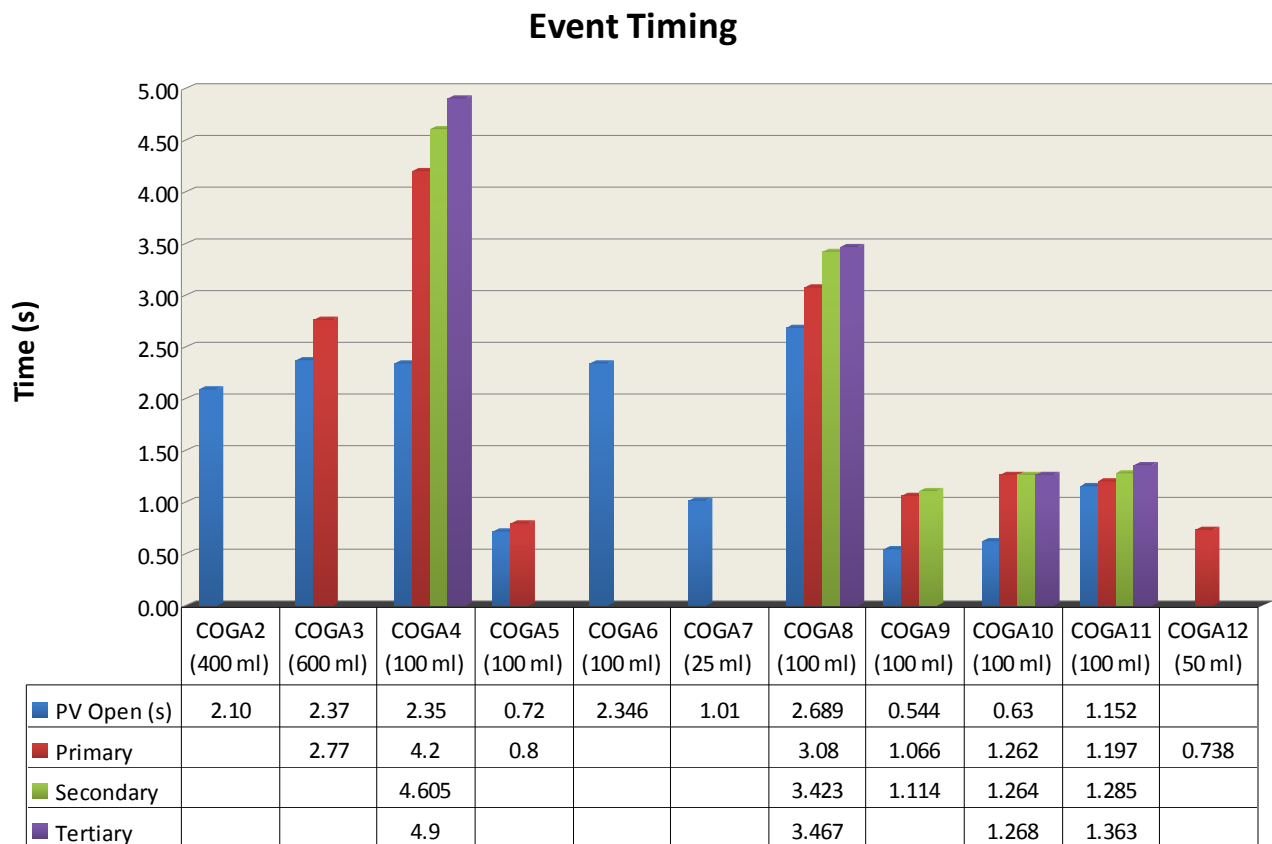
Figure 63
Event Timing Chart

The timing is plotted for each test in Figure 63.
